# RESEARCH MEMORANDUM

CYCLIC ENGINE TEST OF CAST VITALLIUM

TURBINE BUCKETS - II

By J. Elmo Farmer, George C. Deutsch  
and Paul F. Sikora

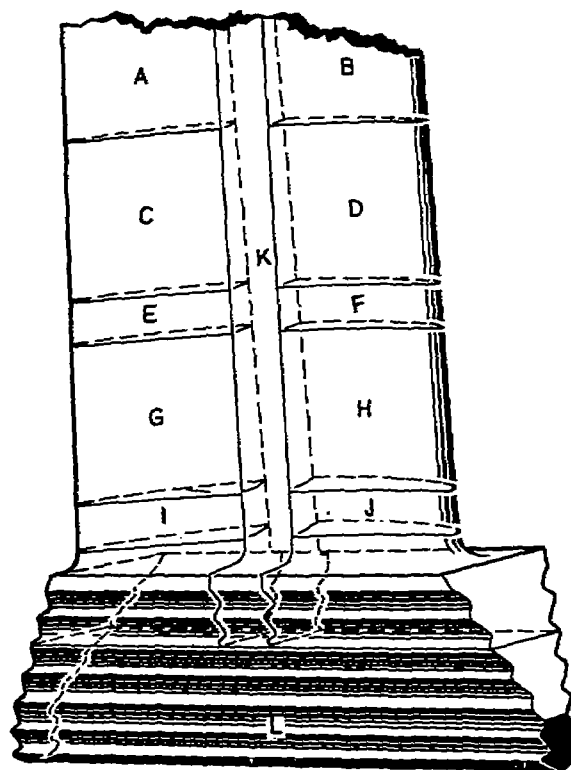
Microexamination. - The blade areas of both the broken and the unbroken buckets were sectioned as indicated in figure 1. Sections A and B were polished for metallographic examination in both the longitudinal and the transverse directions, together with the top transverse surfaces of sections E, F, I, and J. The samples were electrolytically etched in aqueous hydrochloric acid. The transverse samples were rated for carbide-mesh distribution by measuring the number of carbide-island intersections encountered on eight random lines, each 1 inch long at a magnification of 100X. The average of the eight values thus obtained was called the carbide-mesh number.

Figure 1. - Diagram showing manner in which buckets were sectioned to permit metallurgical examination.
